Study On Quality Of Bank Financed Road Projects

Transport, Urban Development & ICT Department

AFRICAN DEVELOPMENT BANK GROUP

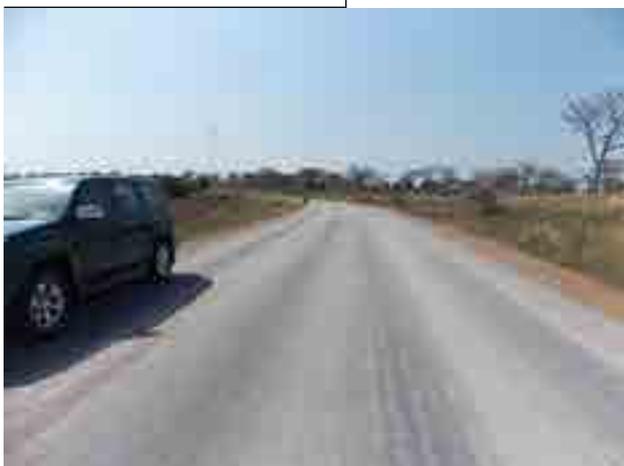
Picture 4.2: Recently Sealed Nandeke Section on Nandeke - Mbere Road Section

deduced as 60 giving a condition rating of Fair; and PSI of 2.83. Riding quality of the road is generally good, even in the sections which are showing signs of distress and the road has been patch repaired or surface dressed.

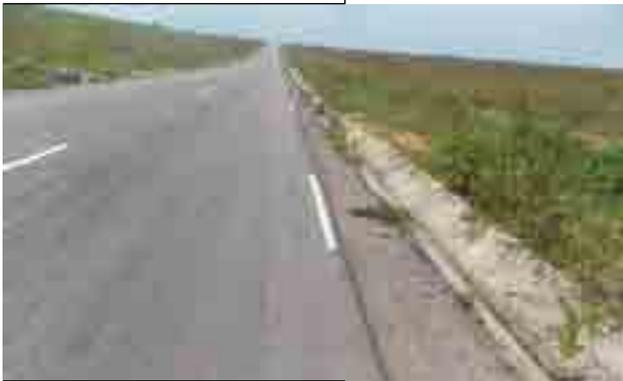
*Picture 4.7: Longitudinal
Cracks in Outer Wheel
Path of Kwango -
Kenge Road Section*

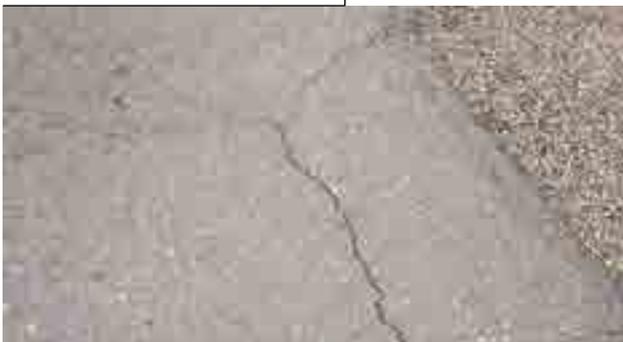
*Picture 4.8: Cracks in the
Pavement for Kwango -
Kenge Road Section*

They therefore do not affect the riding quality but if the necessary intervention is not carried out soon the road could deteriorate very quickly.

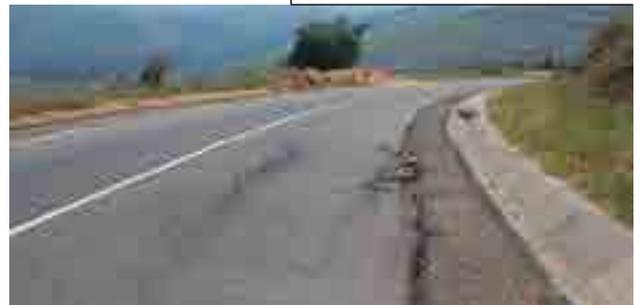
Picture 4.11: Shoving on Kwango - Kenge Road

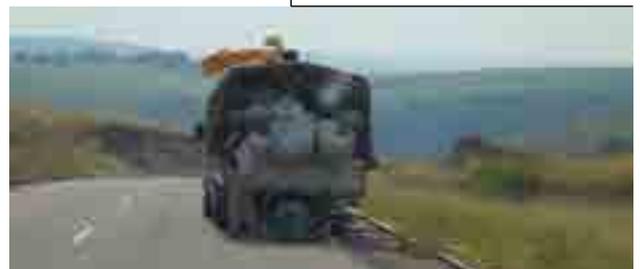
Picture 4.12: Vehicle Being Repaired on Carriageway

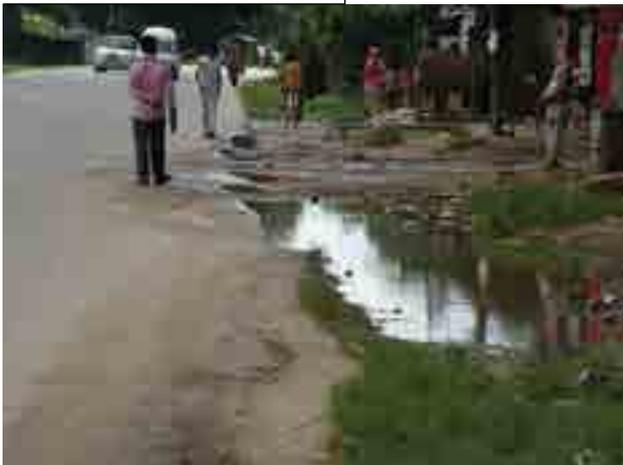
Picture 4.19: Blocked Drain on Manzizini - Fumba Road Section , Zanzibar

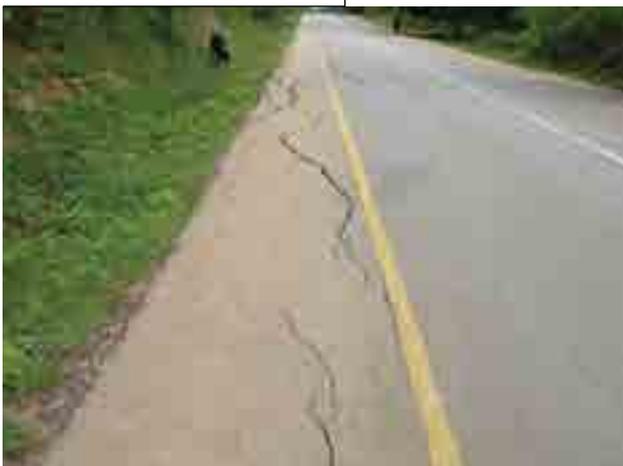
Picture 4.20: Longitudinal Crack on Manzizini - Fumba Road Section, Zanzibar

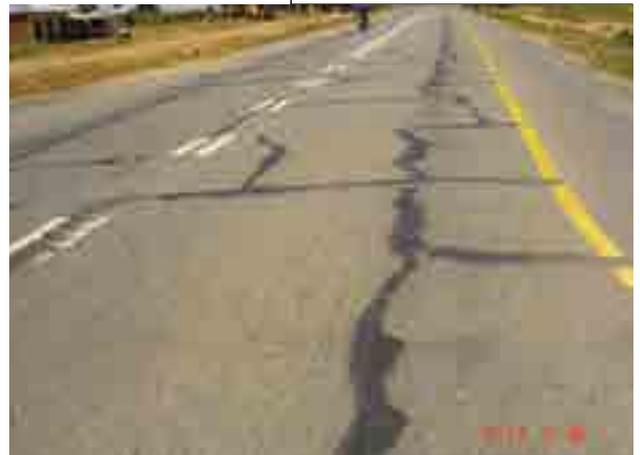
The road however shows considerable unevenness, estimated to cover 1 to 2 percent of the pavement area, the result of settlements or depressions of long wavelengths. A pavement condition score of 67 and a PSI of 3.30 are estimated for the road section giving a pavement condition rating of Fair.

Picture 4.21: Sealed Cracks on Singida- Katesh Road Section Between km 2 and 11

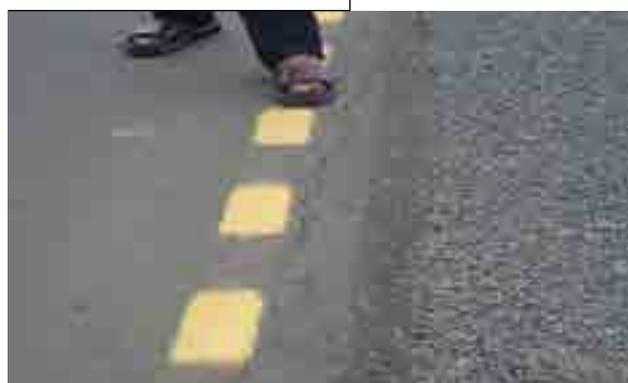
Picture 4.22: Typical Longitudinal Cracking along Carriageway on Babati - Minjingu Road Section, Tanzania.

the pavement has a thin (50 mm thick) asphalt surfacing and a relatively thick layer of 300 mm of cement-stabilized sub-base separated by 150 mm of crushed rock base. Any cracks initiated in the sub-base layer were expected to have been absorbed by the crushed rock base. However the thickness of the base was not thick enough such that the larger cracks could not be absorbed and ended up being transmitted to the asphalt wearing course. A thicker base, of say 225 mm or higher could probably have mitigated the migration of the cracks to the wearing course. The performance should be compared with that of the Nsawam by-pass in Ghana which also has a cement stabilized sub-base but a 200 mm thick crushed rock base and a total of 180 mm in bituminous layers on top of the crushed rock; and has shown no cracking. The cracking may be mitigated by applying a relatively thick overlay of thickness in the order of 100 mm or the application of a geotextile/glass grid and the deepening of the side drains to improve the dissipation of runoff from the adjacent ground.

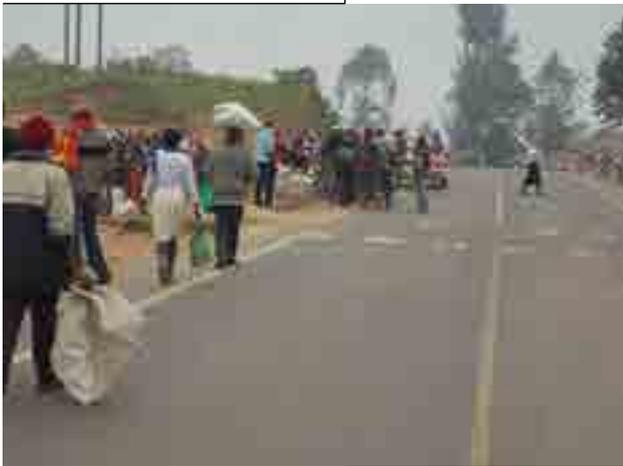
Picture 4.23: Market Posing a Safety Hazard on Kabale - Kisoro Road Section

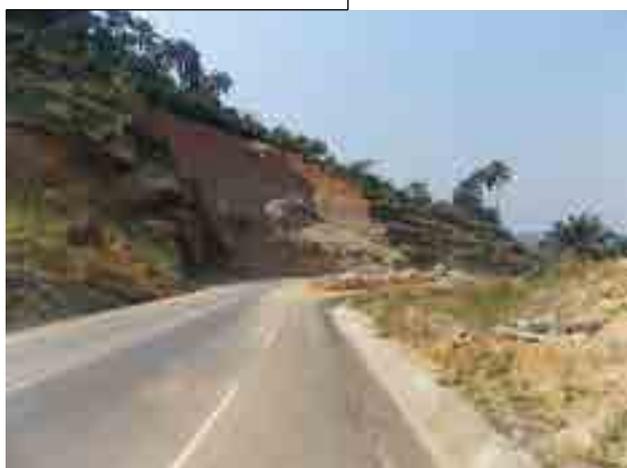
Picture 5.2: Repair of one of the Recurrent Landslides on the Bamenda - Batibo - Numba Road Section, Cameroon

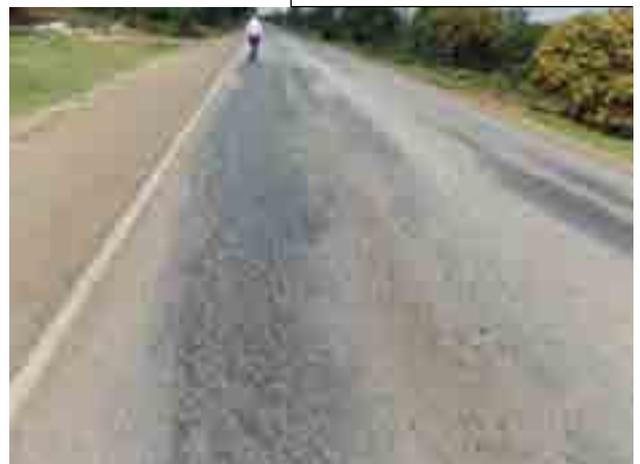
Picture 6.4: Pavement Distress on the Jinja - Bugiri Road Section

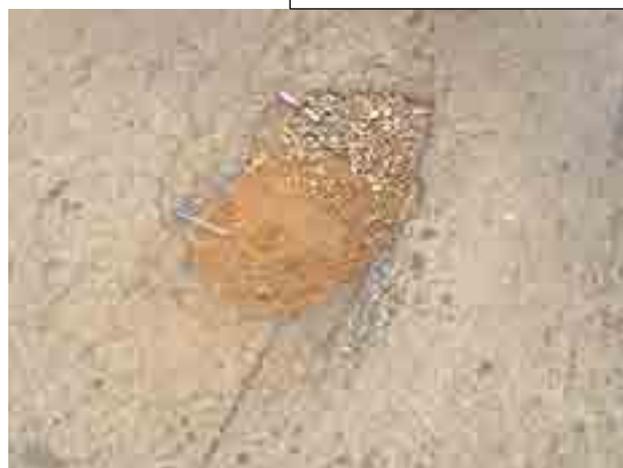
Picture 8.1: : Pothole Developing on Ketou - Pobe Road

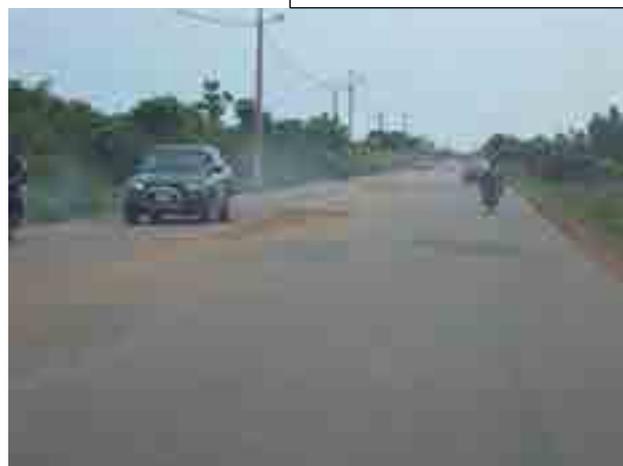
Picture 8.2: Inadequate Maintenance on Lome - Cotonou Route

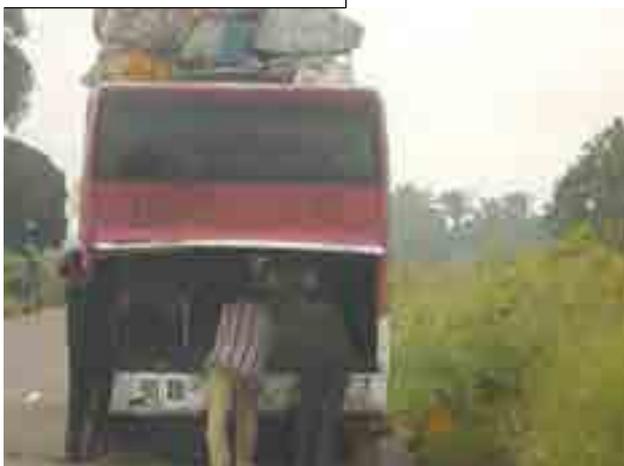
*Picture 8.3: Vehicle Repair
on Nsele Lufimi - Road*

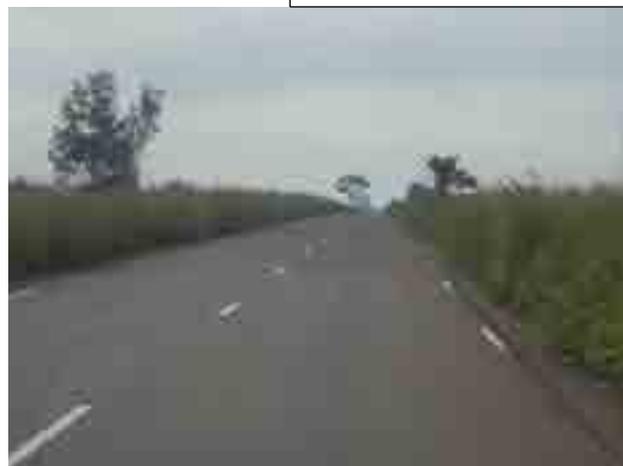
Picture 8.4: : Overgrown Verges on N'sele - Lufimi Road

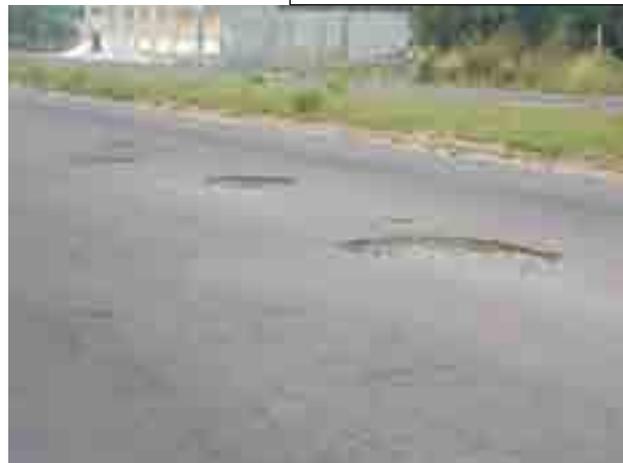
Picture 8.5 Inadequate Maintenance on Lome - Cotonou Route

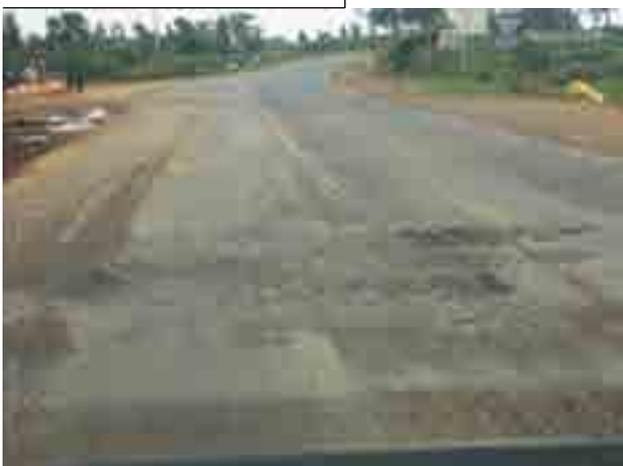
*Picture 8.6: Broken-up
Surface of Nanyuki- Isiolo
Road*
