Study On Quality Of Bank Financed Road Projects

Transport, Urban Development & ICT Department

AFRICAN DEVELOPMENT BANK GROUP

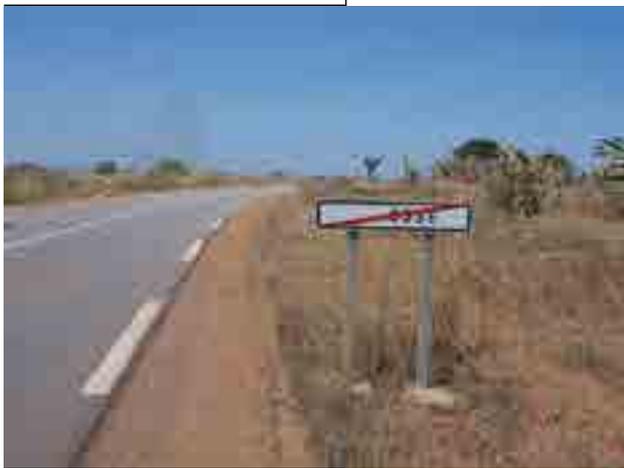
These small patches of surface dressing and patch repairs are quite well spread over a large part of the length. Some of the patch repairs are older than most others of recent origin. Enquiries with the local people revealed that the surfacing had been cracking and the sections that had got badly cracked were being patch repaired as shown in Picture 4.3, whereas sections with moderate cracking were being surface dressed. The sealing of the cracks would prevent the ingress of surface water and delay the deterioration of the road. Some other sections which show cracking, but have not been surface dressed, do not show any distress other than cracking.

The road, other than cracking shows no distress such as raveling, potholing, rutting. The pavement condition score is

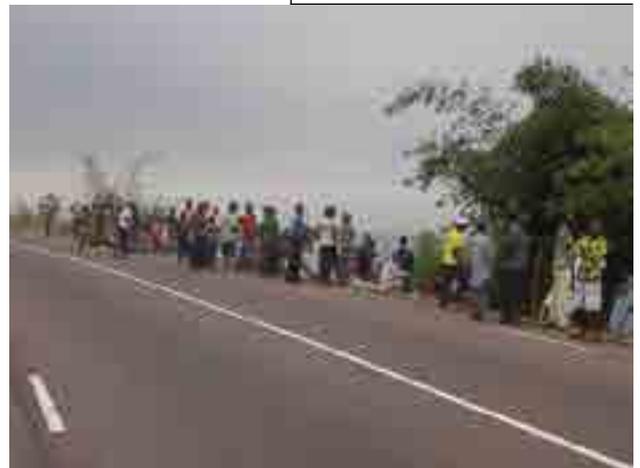
Around km 7, that is near Nsele Bambou, part of the Nsele bound carriageway is being used as a market. This a serious safety hazard as shown in Picture 4.4.

Picture 4.4: Market on Part of Carriageway and Shoulder at Nsele Bambou

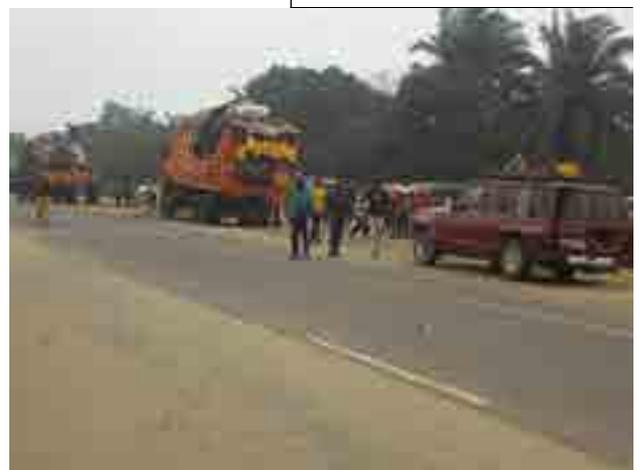
The settlement of Mankao (around km 23) also raises some safety concerns. There is inadequate separation of pedestrians, hawkers selling at a nearby market and through traffic. There is therefore a melee of moving vehicles, pedestrians, parked vehicles, vehicles being repaired on the shoulders resulting in chaos. This is a serious safety hazard that needs to be investigated and resolved to avoid accidents in the future. The user conflict is illustrated in Picture 4.5.

Picture 4.5: Road User Conflict in Mankao

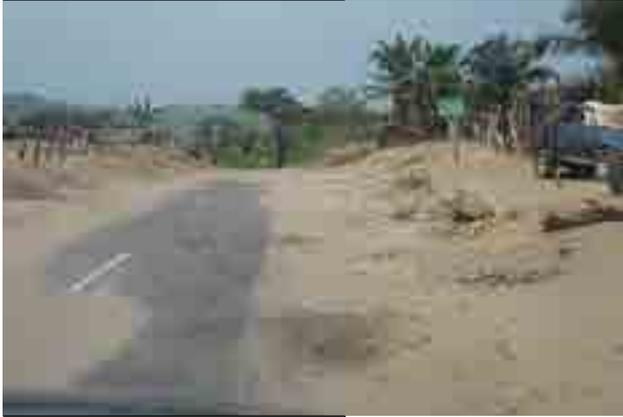
*Picture 4.6: Sand from
Adjacent Higher Ground
Covering Carriageway*

The geometric has been properly carried out for the design speed of 80 km/hr. which is appropriate for the terrain. Road line markings and relevant road signs have been provided. There are speed humps at the entry of all settlements from both directions slowing down vehicles crossing these settlements. Most of the settlements were not provided with drains and in settlements where the surrounding ground is higher than the road level, a lot of sand has been transported across the carriageway, sometimes almost covering the entire carriageway and creating a safety hazard, especially at night. An example is shown in Picture 4.6.

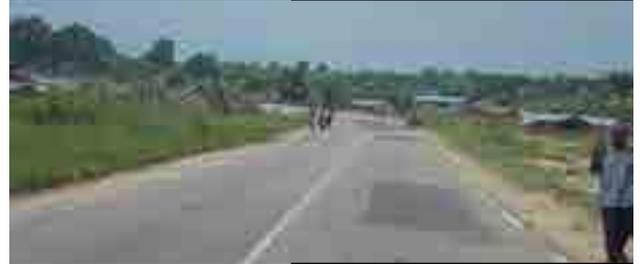
Picture 4.9: : Patching on Kwango - Kenge Road Section

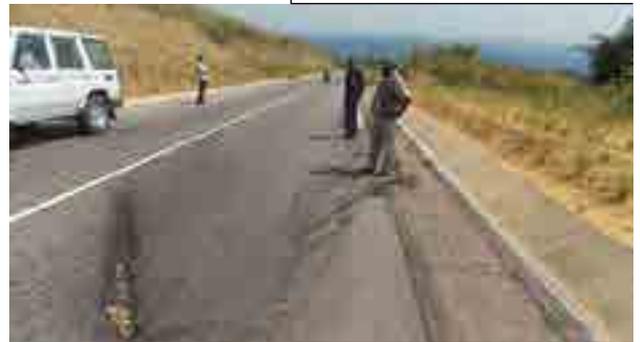
Picture 4.10: Tearing on Kwango-Kenge Road

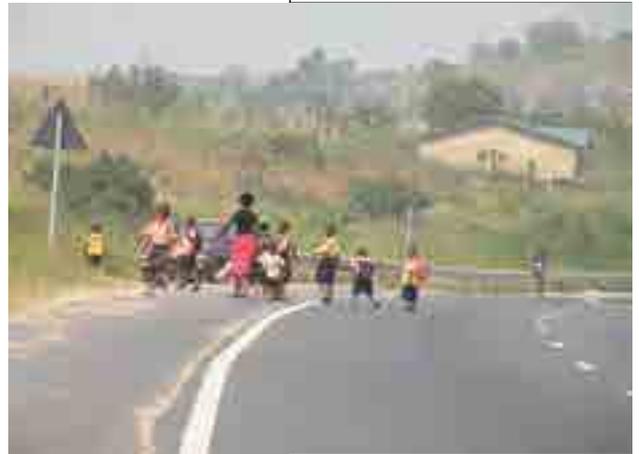
The road section has been adequately marked. Adequate, warning, advisory and information signs have also been provided. Guard rails have been provided where necessary. There are some isolated communities located to the south of the road. These communities access social services in Nsawam mainly by foot necessitating the crossing of the high speed bypass. There is a high potential for vehicular - pedestrian accidents. This has been exacerbated by the dualization. There are no U- turns and motorists have created unauthorized turns through the median. This also poses a serious threat to safety. Pictures 4.14 and 4.15 illustrate the safety challenges described above which would need to be addressed.

Picture 4.14: : School Children Crossing Nsawam Bypass in Ghana

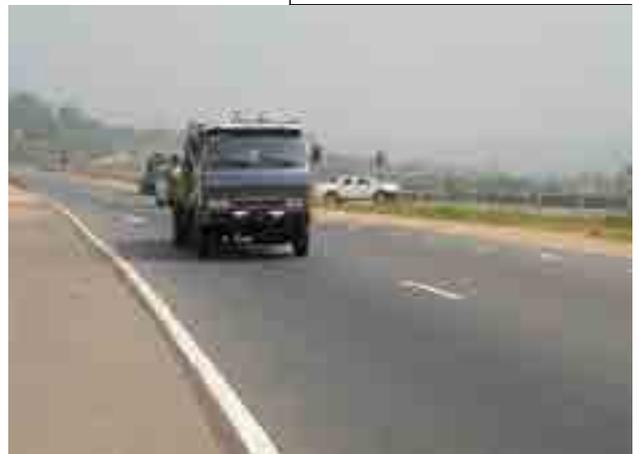
Picture 4.15: Unauthorized U-Turn on Nsawam Bypass

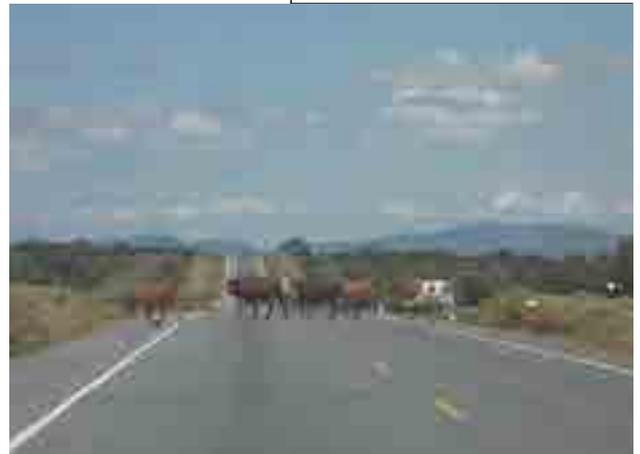
Picture 4.17: Cattle Crossing the Athi River - Namanga Road Section

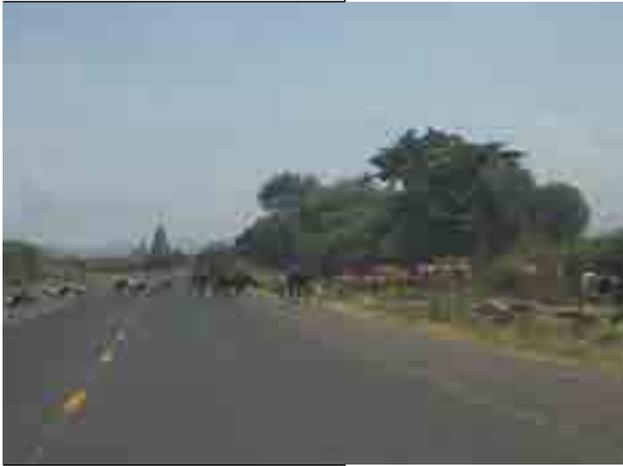
Picture 4.18: A Herd of Cattle and Sheep Crossing the Isiolo - Merille Road Section

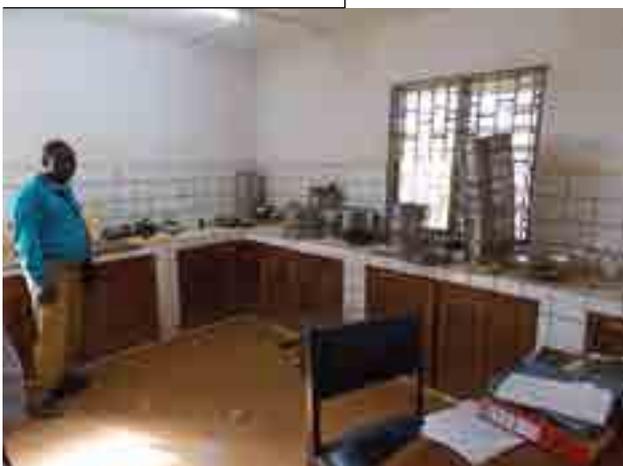
The quality control procedures adopted were the same for all the Study Countries. Laboratories were established on each of the construction projects and provided with the necessary equipment as per contract conditions. Pictures 5.3 and 5.4 show the laboratory set up on the Nandeke - Mbere road section in Cameroon. The study of the progress reports and the files for Quality Control suggests that quality control was adequately carried out on the projects.

Picture 5.4: Part of Soils Laboratory for Nandeke - Mbere Road Project

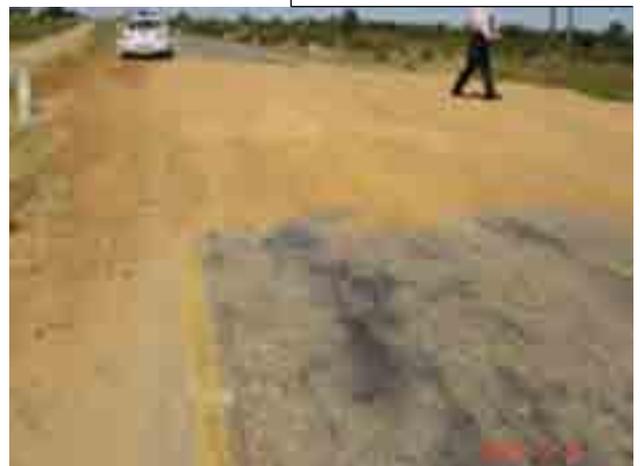
The performance of all three lots is generally good except that a short section of Lot 1 has been washed away as shown in Picture 6.1. A short section of Lot 2 has also seen some cracking and patching as shown in Picture 6.2.

*Picture 6.1: Singida-Shelui
(Lot 1: Singida-Iguguno
Section Washed
away road at Chainage
16+700km*

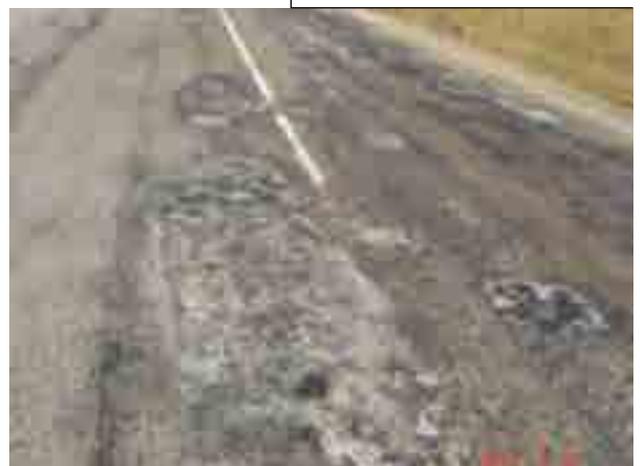
*Picture 6.2: Singida-Shelui
Lot 2: Iguguno-Misigiri
Section, km 39+000*

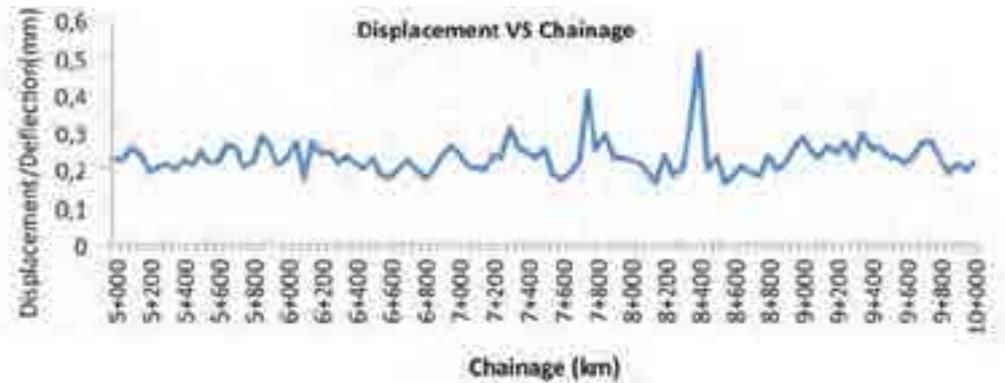
Figure A2.2.7-8: Maximum Deflections for Khlidia - Jbel Rsas Road Section
